## Early Response System and Improvement of Fire Safety Performance In Dae-gu Subway Disaster.

### Abstract

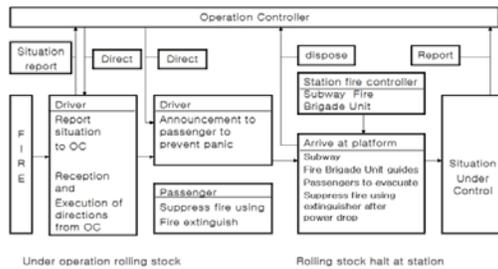
In the first stage, the driver should have reported the fire to the operation controller and waited for an appropriate order before moving the train to the nearest station.

He also should have informed the situation to the passengers and attempted to extinguish the fire when the rolling stock arrived at the platform, with the aid from the subway fire brigade unit, while at the same time conducting spontaneous evacuation for passengers.

Also the drivers should have attempted to suppress fire with passenger by using potable foam extinguishers upon operation controller's command. The driver should not have, moreover, moved the train without a command from the operation controller.

Figure 2. Emergency response for fire at rolling stock.

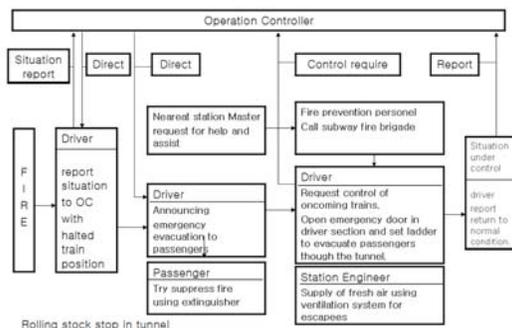
Figure 3. Emergency response for rolling stock in tunnel fire.

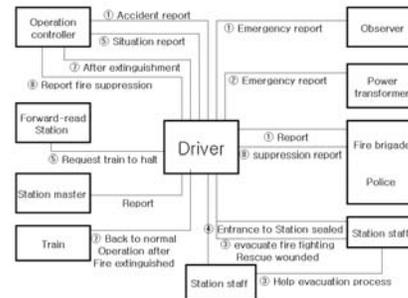
The study of Japanese emergency response procedure shows that most of early response judgement and action is made by the driver. He orders shut down of a power transformer and departure of stationed trains

at the neighbouring station, while at the same time calling fire brigade and police.

This is followed by operation controller's order for passenger evacuation, and then order to the driver to attempt to suppress fire.

In the meanwhile the stationmaster and staffs close the entrance to the station and rescue the wounded.

Figure 4. Nagoya subway fire emergency response procedure.
