SURVEY ON FIRE SERVICE INSTALLATIONS FOR OFFICE BUILDINGS IN HONG KONG

E.C.L. Pang and W.K. Chow

Research Centre for Fire Engineering, Area of Strength: Fire Safety Engineering
The Hong Kong Polytechnic University, Hong Kong, China

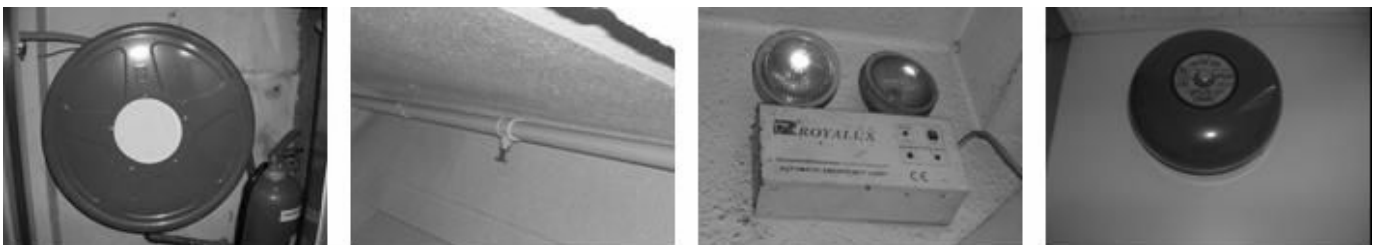
It is a multi-purpose building in To Kwa Wan (as shown in Fig. 1) constructed before the publication of the first codes of practice on FSI and there was no FSI installed. Since the owner was quite concerned about the fire safety inside, lots of renovation works were carried out in the 1990s which involved hose reel system, fire extinguishers, improvised sprinkler system, emergency lighting and manual fire system as shown in Figs. 2a to e.

(a) Hose reel and fire extinguisher (b) Sprinkler installed (c) Emergency light (d) Alarm bell

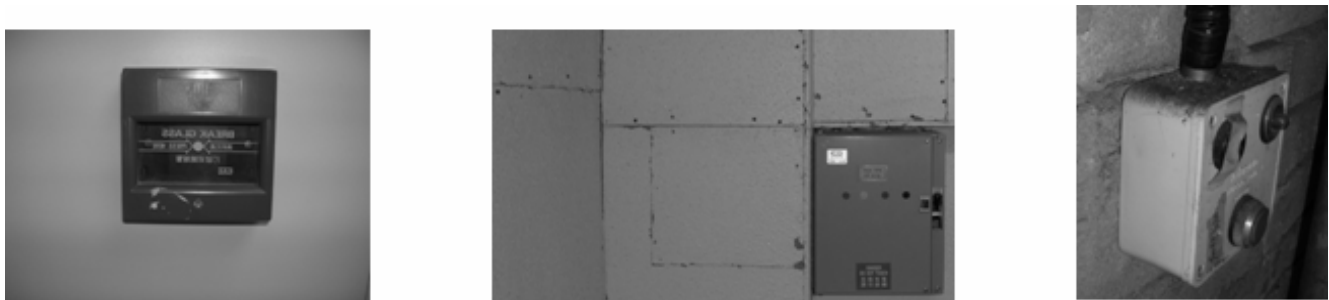
Additional electricity supply was not necessary. One new essential power switch as shown in Fig. 2f is sufficient. It is installed in one of the staircases (escape routes) with fire rated materials to cover up the cables.

However, the manual pump starter for sprinkler system has deteriorated as in Fig. 2g. Of course, there are other minor problems observed during the site visit mainly due to improper management and maintenance.

(e) Manual alarm call point (f) Essential power switch (g) Deteriorated sprinkler pump manual starter

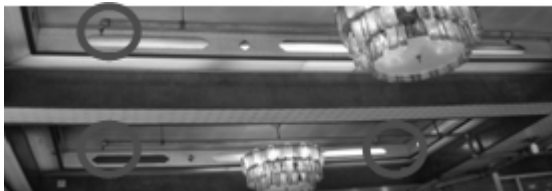
It is a composite building with a restaurant in Yau Ma Tei as in Fig. 1 which has been in use since 1971 and it should have complied with the codes at that moment. Sprinkler system was added for the premise as in Fig. 3 few years ago in accordance with the legislative requirement.

Since other required FSI were not checked in detail, renovation works in the premises were not clear. To the best knowledge, the management like to cover up those equipments with better outlook and compatible colours. Hence, those equipments are not easy to be activated, found or noticed. The problems are on slower response for the detectors and sprinklers; people might not fight against the fire by hose reel; and the occupants have to spend more time on locating the exits.

FIGURE 3. Sprinkler in the restaurant in EB2
