# **RECONSTRUCTION OF POST-EARTHQUAKE FIRE IN INARIYAMA POST TOWN**

NAKAO Miho and TANAKA Takeyoshi  
Disaster Prevention Research Institute, Kyoto University  
Gokasho, Uji, Kyoto 611-0011, JAPAN  
[nakao@drs.dpri.kyoto-u.ac.jp](mailto:nakao@drs.dpri.kyoto-u.ac.jp), [takey@drs.dpri.kyoto-u.ac.jp](mailto:takey@drs.dpri.kyoto-u.ac.jp)

## **ABSTRACT**

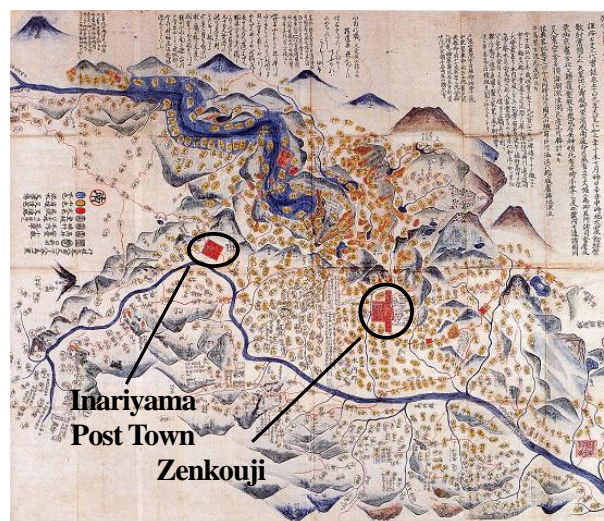
Figure 1: Picture of the state of the Zenkouji Earthquake [2]

Fig.1 shows the damage of the fires, floods and landslides occurred by the Zenkouji Earthquake, the fires broke out at the areas shown by red color, the foods happened at the blue area along river and the landslides occurred at the yellow areas. The landslides intercepted rivers and floods occurred as the dams formed by the landslides eventually collapsed, as shown in Fig.1. Inariyama post town was on Zenkouji Highway that was prosperous in the period of Edo and located now in Koushoku City, Nagano, which lies in the south of Zenkouji. Fires also broke out in Inariyama post town by Zenkouji Earthquake.

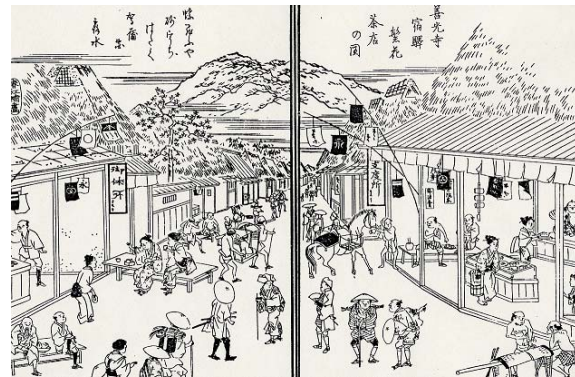
(b): Zenkouji post town before the Zenkouji Earthquake in 1847 [6]

Fig. 4(b) shows a picture that shows the state of Zenkouji post town in the first period of 1840, before Zenkouji Earthquake. The roofs of main houses were straw roofs, and only the part of pent roof was shingle roof. It is considered that the shape of houses was similar in many towns around Zenkouji including Inariyama post town. And, in Matshubayashi house records [4] exemplified by Table 2, the indication of tiled roof is few, so in this attempts to reconstruct Inariyama post town, it is assumed that the roof of a main house was straw roof and the pent roof was shingle roof.

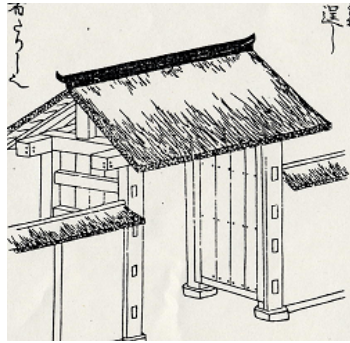
Figure 5: Gate of the Honjin in Inariyama [6]

The Honjin, an officially appointed inn for daimyos and their followers, existed in Inariyama post town. “Noted Places Along Zenkouji Highway” [6], which is a book that introduced sights seeing spots around Zenkouji for travelers, recorded the Honjin in Inariyama before the Zenkouji Earthquake. It said that the width of the gate was nine shaku (is 2.7 m) and was constructed with four pillars. The picture of the gate of Honjin is shown in Fig. 5. The floor plan of officially appointed inn in Inariyama is shown in Fig. 6 [8], although it was after the Zenkouji Earthquake that the plan was drawn. The shape of Honjin is based on the pictures and landscapes of Zenkouji around 1847 as shown in Fig. 4(c). On the basis of these pictures, an attempt was made to reconstruct the Honjin in Inariyama, the picture of reconstructed the Honjin is shown in Fig. 7(c).

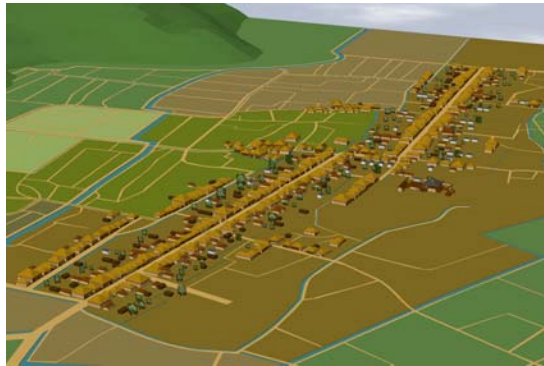
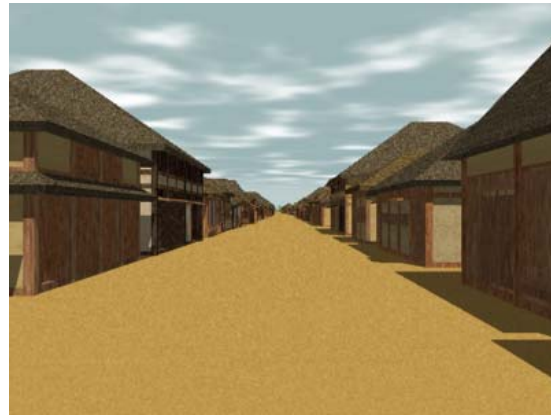
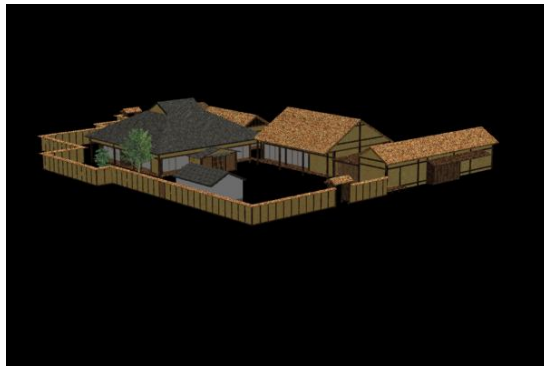
Figure 7: The reconstruction of Inariyama post town at that time of Zenkouji Earthquake

Fig. 7 shows the state of Inariyama post town at the time of Zenkouji Earthquake reconstructed on the basis on the materials presented in 4.1 - 4.5. The plans of topography and houses and the Honjin are drawn using Vector Works, and the animations of them were made using Shade. The solar altitude at the time of Zenkouji Earthquake 24 March (8 June, new style) in 1847 was investigated, so shadow is reflected in these pictures. Fig. 7(a) shows the bird's-eye view of the town, Fig. 7(b) shows a part of the row of stores and houses along the main street, and Fig. 7(c) shows Honjin.

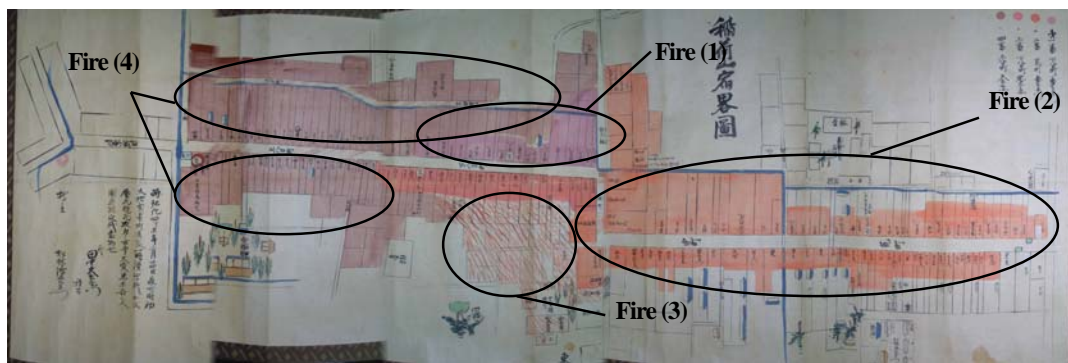
Figure 8: Map of the Inariyama post town [9]

The Zenkouji Earthquake destroyed many houses, and fires broke out at four different locations. Fig. 8 shows the areas destroyed by each of these fires. On the basis of this map and the description of the fires described by one Matsubayashi Yagoemon, the first fire started immediately after the time of the quake, around 10 p.m., and destroyed eighteen houses. The second fire started around 11 p.m. that burnt down eighty-five houses before it was naturally extinguished around 10 a.m. in the following morning. The third fire, which destroyed thirty-four houses, began around 7a.m. and extinguished in the same morning. The last of the four fires was also started and extinguished that morning, leaving eighty-three destroyed houses as shown in Table 3. The total of 220 houses were burnt to ash; only sixty houses and twenty warehouses were left intact. The time of the outbreak of the fires, extinguishments of fire and the number of burnt houses in each fire are comprehended fragmentarily. But the information is not complete, so the unknown part is also significant.
