Investigating the Vulnerabilities of Structures to Ignition From a Firebrand Attack

SAMUEL L. MANZELLO¹, JOHN R. SHIELDS¹, YOSHIHIKO HAYASHI², and DAISAKU NII²

¹Building and Fire Research Laboratory (BFRL)
National Institute of Standards and Technology (NIST)
100 Bureau Drive, Gaithersburg, MD 20899-8662 USA

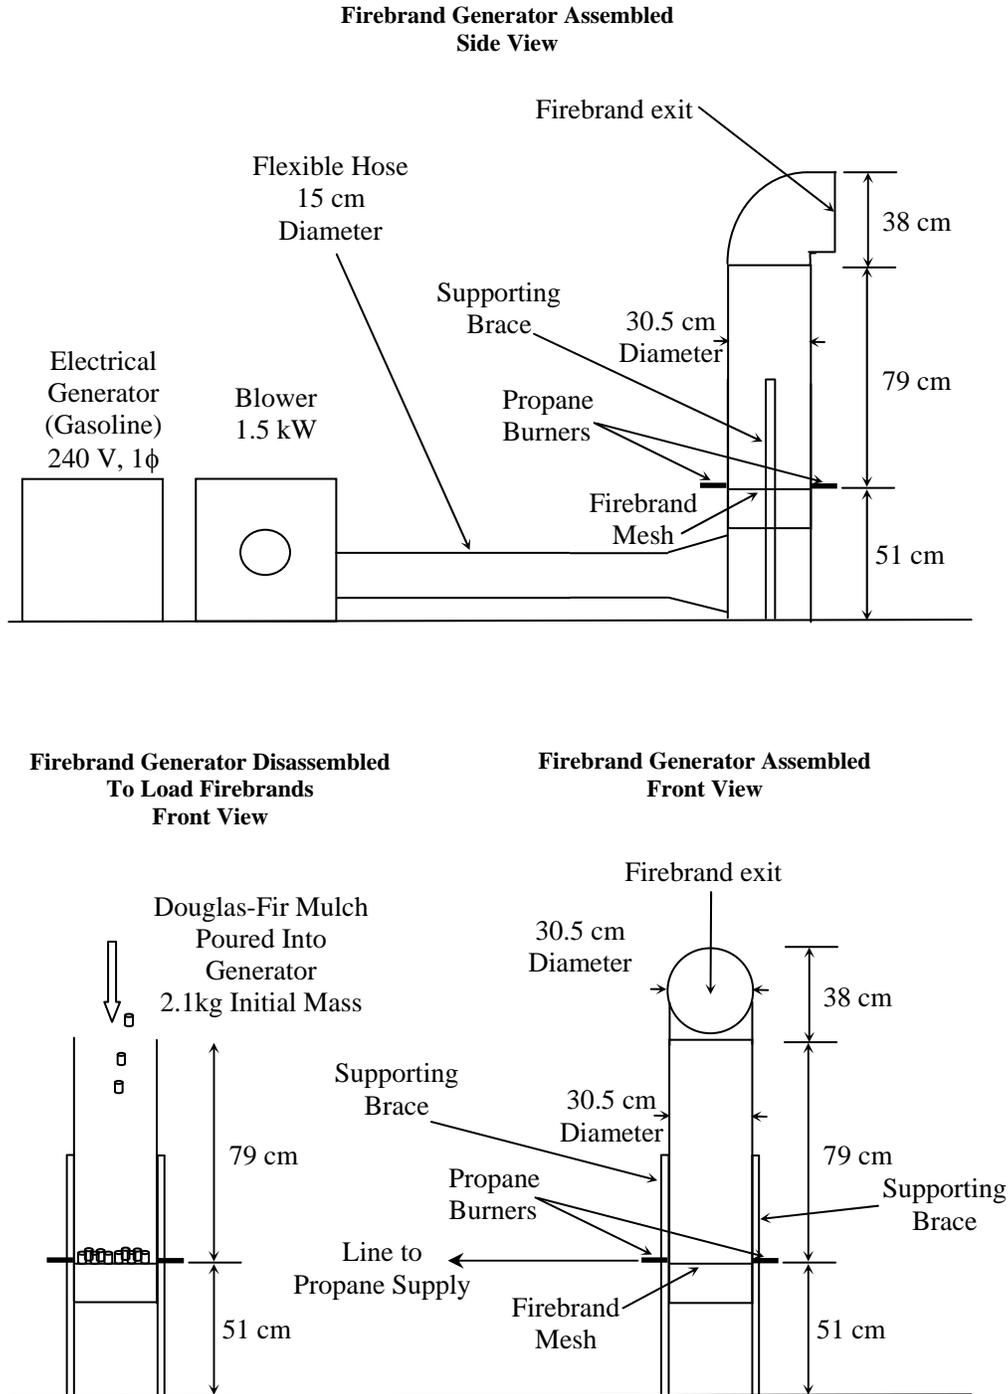
Fig. 1. Firebrand Generator - Top Panel shows the device fully constructed while the bottom panel displays the procedure for loading the device.

Figure 1 is a drawing of the experimental apparatus. The present apparatus is a scaled up version of a smaller first generation, proof-of-concept device [14]. The current, scaled up version of the device has been described elsewhere and has been used to investigate the penetration of firebrands into building vents [12]; a brief description of the device is provided here for completeness. The bottom panel displays the procedure for loading the Douglas-Fir tree mulch into the apparatus. The mulch pieces were deposited into the firebrand generator by removing the top portion. The mulch pieces were supported using a stainless steel mesh screen (0.35 cm spacing), which was carefully selected. Two different screens were used to filter the mulch pieces prior to loading into the firebrand generator. The first screen blocked all mulch pieces larger than 25 mm in diameter. A second screen was then used to remove all needles from the mulch pieces. The justification for this filtering methodology is provided below. A total of 2.1 kg of mulch was used as the initial mass for each of the experiments. The average moisture content of the mulch pieces used at ignition was 10 % (dry basis). The mulch was produced from 4.0 m Douglas-Fir trees. The

firebrand generator was driven by a 1.5 kW blower that was powered by a gasoline electrical generator. The gasoline electric generator provided the blower with the necessary power requirements (see Fig. 1). These power requirements were not available at the FRWTF, necessitating the use of a portable power source.

After the Douglas-Fir tree mulch was loaded, the top section of the firebrand generator was coupled to the main body of the apparatus (see Fig. 1). With the exception of the flexible hose, all components of the

apparatus were constructed from either galvanized steel or stainless steel (0.8 mm in thickness). The blower was then switched to provide a low flow for ignition (1.0 m/s flow inside the duct measured upstream of the wood pieces). The two propane burners were then ignited individually and simultaneously inserted into the side of the generator. Each burner was connected to a 0.635 cm diameter copper tube with the propane regulator pressure set to 344 kPa at the burner inlet; this configuration allowed for a 1.3 cm flame length from each burner. The Douglas-Fir mulch was ignited for a total time of 45 seconds. After 45 seconds of ignition, the fan speed of the blower was increased (2.0 m/s flow inside the duct measured upstream of the wood pieces). The burners were subsequently switched off at 90 seconds after ignition. This sequence of events was selected in order to generate a continuous flow of glowing firebrands for approximately six minutes duration. The principle behind the operation of the apparatus was rather simple, after ignition, the mulch would begin to burn and the density decreased until which point the low air flow passing through the support mesh was able to loft and exit the device as firebrands at low velocity. The timing and fan blower speed timing is not random; if a higher fan speed of the blower was selected, the firebrands produced would be forced out of the exit earlier, resulting in flaming firebrands, which was not desired.

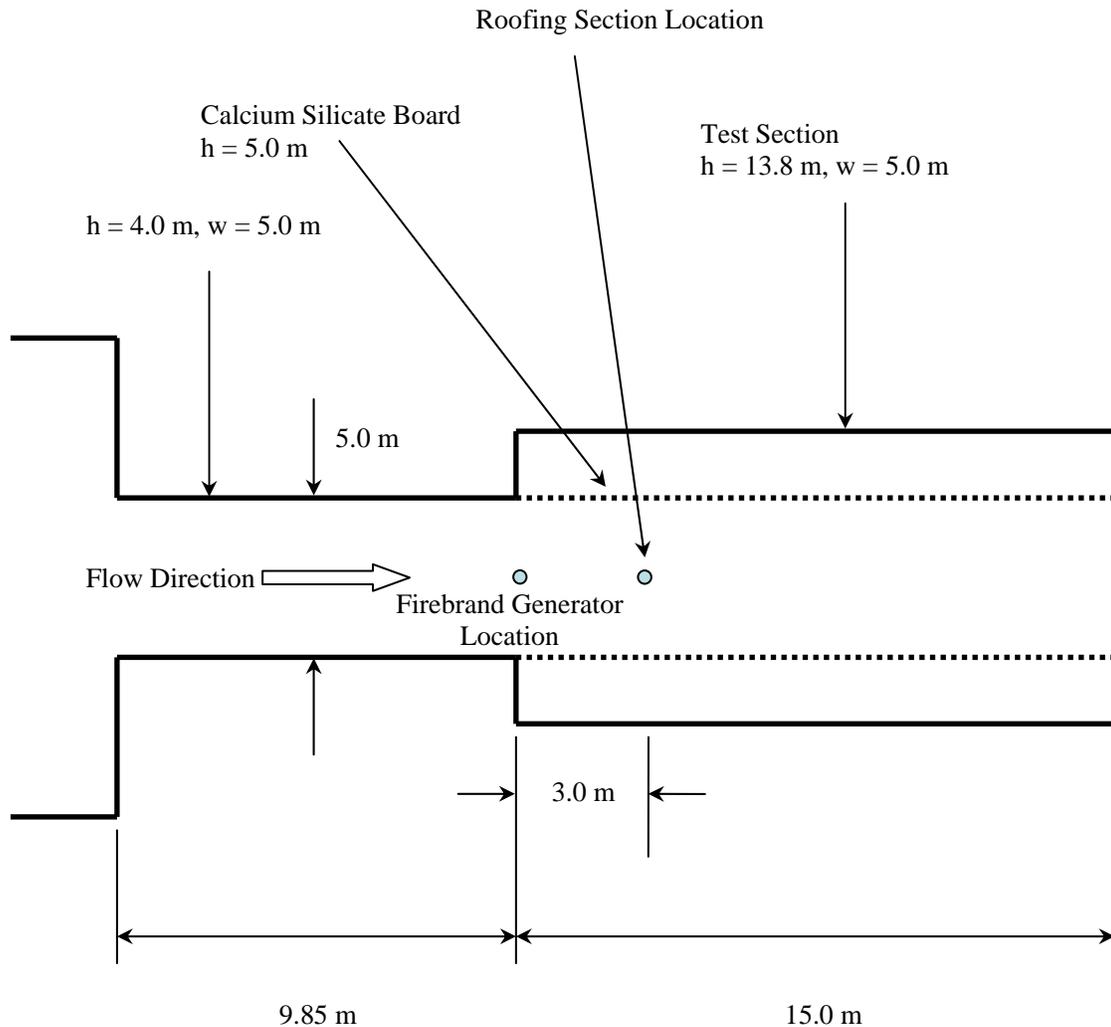
Fig. 2. Schematic of the FRWTF (Top View). The location of the Firebrand Generator with respect to the roofing assemblies is shown.

The Firebrand Generator was installed inside the test section of the FRWTF at BRI. A drawing of the facility is shown in Fig. 2 and displays the location of the firebrand generator with respect to the roofing sections used for ignition testing. The facility was equipped with a 4.0 m fan used to produce the wind field and was capable of producing up to a 10 m/s wind flow. The wind flow velocity distribution was verified using a 21 point hot wire anemometer array. To track the evolution of the size and mass distribution of firebrands produced, a series of water pans was placed downstream of the Firebrand Generator. Details of the size and mass distribution of firebrands produced from the device are presented below.

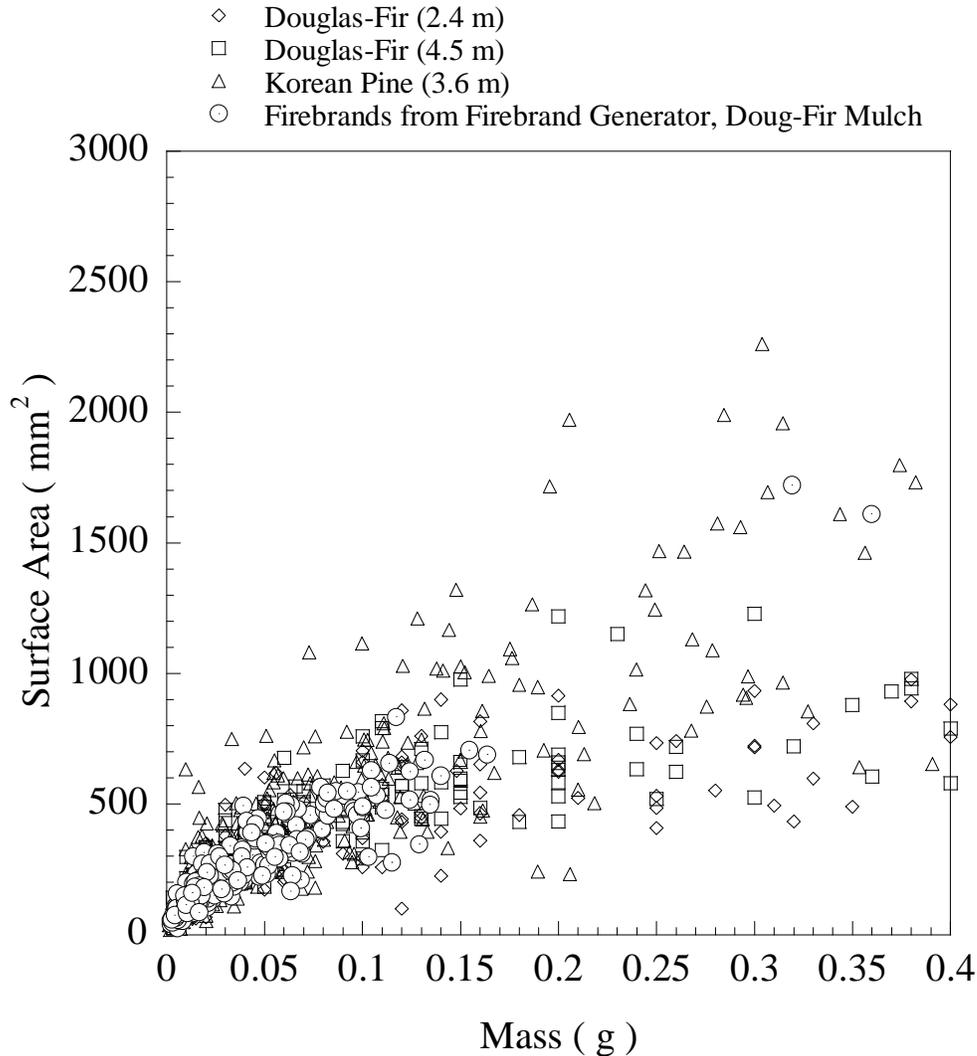
Fig. 3. Firebrands produced from Firebrand Generator compared to firebrands collected from burning trees. The dimensions assigned to the trees correspond to crown heights.

In a similar manner to prior work, it was desired to be able to produce firebrands that are characteristic of those produced by burning trees. In prior work characterizing the size and mass distribution of firebrands generated from burning trees, it was observed that the mass distribution of firebrands produced from two different tree species under similar moisture levels and crown size ranges were similar for mass classes up to 0.4 g [15-16]. A noticeable difference was observed in the larger mass classes. It was also observed that more than 85 % of the firebrands produced from trees were in mass classes up to 0.4 g. Accordingly, the input conditions for the firebrand generator were intentionally selected to produce firebrands with mass classes up to 0.4 g. This was accomplished by sorting the Douglas-Fir tree mulch using a series of filters prior to being loaded into the firebrand generator. The same filtering procedure was used previously when Korean Pine trees were used as the mulch source [12].

The firebrands produced from the Firebrand Generator were captured using an array of water filled pans. The generated firebrands landed in the water filled pans and the presence of water quenched combustion. The firebrands were subsequently removed from the water pans and dried. Since many of the firebrands produced are cylindrical, the length and diameter of the generated firebrands was measured. This information was then used to calculate the surface area of the firebrands produced and was plotted as a function of the measured firebrand mass (see Fig. 3). Figure 3 also displays the same analysis performed for firebrands collected from Douglas-Fir trees as well as Korean Pine Trees under similar moisture content. From the figure, the firebrand generator was capable of producing the size and mass distribution of firebrands from burning trees up to 0.4 g.

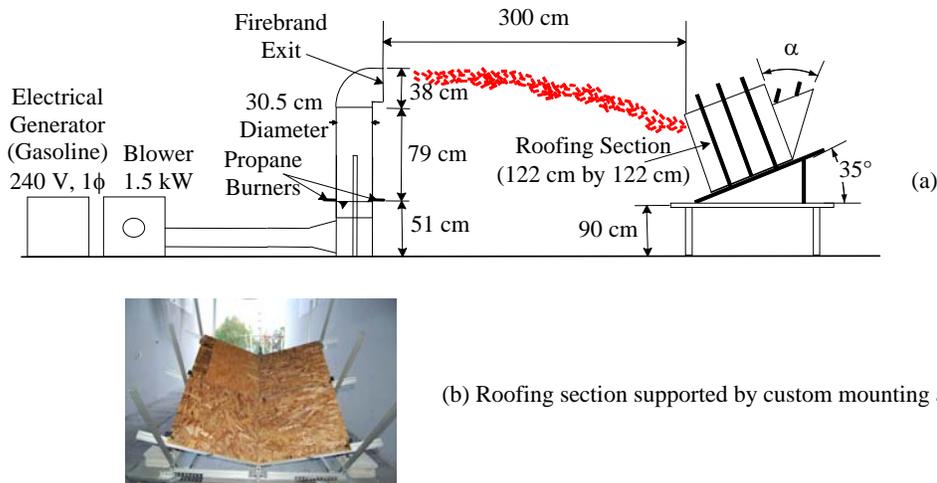
Fig. 4. Firebrands deposited onto full scale roofing sections; (a) side view (b) front view-detail.

After the size and mass distribution of firebrands produced from the Firebrand Generator was determined, a custom mounting assembly was constructed to support full scale sections of common roofing materials inside the wind tunnel. For all the tests conducted, the generator was located 3 m from the mounting assembly. A schematic of the mounting assembly is shown in Fig. 4.

Consequently, the first series of experiments conducted at the FRWTF consisted of full scale sections of base layer roofing materials; OSB was used. In these experiments, a full scale section (122 cm by 122 cm by 9 mm thick) of a roof was installed inside the custom mounting assembly (shown in Fig. 4). The pitch

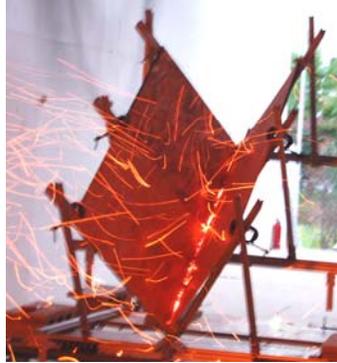
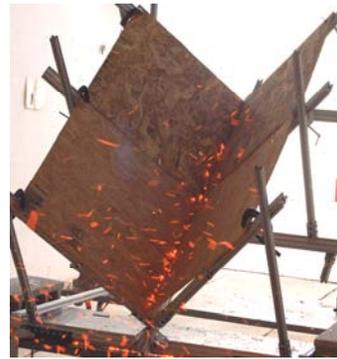
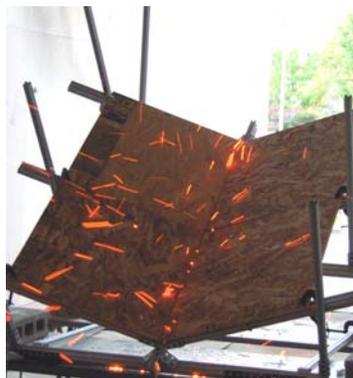
Fig. 5. Bare OSB full scale sections used for testing. (a) Angle of 60° ; smoldering ignition observed (b) Angle of 90° ; smoldering ignition observed (c) Angle of 135° ; no ignition observed.

Figure 5 displays a sequence of images obtained from the present experiments. Similar to the small scale experiments, ignition events were not observed for moist samples; ignition only occurred when the OSB samples were oven dried. This can be explained by the higher heating value and thermal inertial of the samples. The moisture embedded in the samples reduces the thermal efficiency since the heating and gasification of water consume additional energy. Consequently this will result in the high value of heat of gasification, reducing the net heat flux to the fuel bed. The moisture content is also known to affect the density of the fuel bed material, the thermal conductivity, and the specific heat, and thus the thermal inertia. A high thermal inertia value for a wet fuel bed increases a thermal resistance to changes in temperature, reducing ignitability.

At an angle of 60° , the firebrands were observed to collect inside the channel of the OSB crevice. The dynamics of the ignition process were repeatable and very interesting to observe. The firebrands that collected in the crevice produced smoldering ignition where they landed, eventually resulting in several holes in the OSB. The OSB continued to smolder intensely near the locations where the firebrands landed. Eventually a transition to flaming ignition was observed on the back side of the OSB. As the angle was increased to 90° , similar behavior was observed where the firebrands that collected initiated intense smoldering. Eventually, holes were formed at these locations in an identical manner to the 60° . While smoldering ignition was observed, it was not possible for a transition to flaming to occur. As the angle was increased to 135° , ignition was no longer possible. The wind tunnel flow was set to 7 m/s in these experiments; this corresponded to a 4.8 m/s velocity at the center of the OSB crevice.

In these experiments, the shingles used were new and care was taken to seal each row of shingles. For older roofs found in practice, aged shingles would not be expected to perform as well as new shingles since they would not be expected to be sealed well along the seams due the weathering process. In addition, the present experiments did not consider the influence of pre-heated shingles. In actual fires, the shingles are not expected to be cold (20 °C) since they will, at minimum, be pre-heated by solar radiation. In light of these differences, the present results clearly indicate that firebrands can melt new, cold, asphalt shingles. Once the firebrands penetrate the shingles, the base layer material (OSB) was found to be ignited rather easily (see Fig. 5).

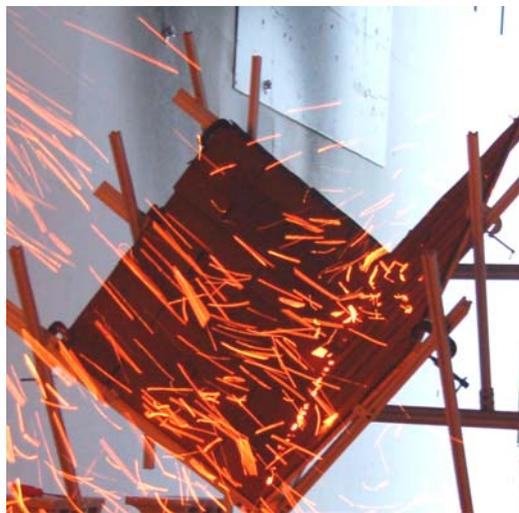
Fig. 6. OSB base layer, tar paper, and asphalt shingles; Angle of 90°-no ignition observed.

Figure 6 displays the results obtained at angle of 90°. At 60° and 90°, several firebrands were observed to become trapped along the crevice of two sections and along the seams of the shingles. However, no ignition events were observed. The firebrands were only capable of melting the asphalt shingles. As the angle was spread further, fewer firebrands were observed to become trapped in seam of the two sections, in similar manner to base OSB tests described in Fig. 5.

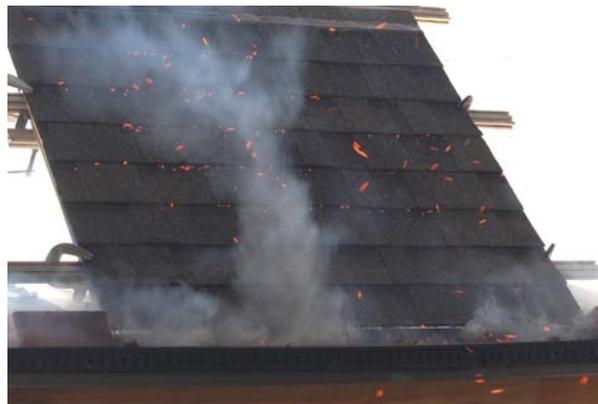
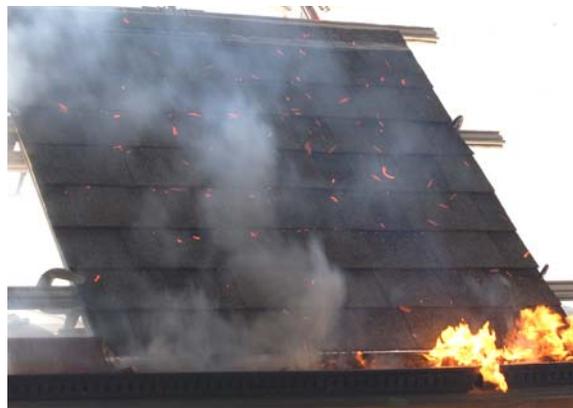
Fig. 7. Section of full scale roof assembly. (a) Smoldering ignition of needles/leaves inside gutter (b) Transition to flaming ignition.

Figure 7 displays typical results obtained from the experiments. The firebrands that were deposited inside the gutter produced smoldering ignition inside the gutter. The smoldering intensified and ultimately this transitioned to flaming ignition. The asphalt shingles were observed to melt once exposed to the intense flaming that occurred inside the gutter. The flames, however, did not spread up the roof section. While the flames did not spread upwards along the roof, these images are very important to disseminate to home owners in WUI areas since they clearly show the dangers of simply not cleaning gutters. The influence of pre-heated shingles as well as aged shingles was not addressed.
