SURVEY ON FIRE SERVICE INSTALLATIONS FOR OFFICE BUILDINGS IN HONG KONG

E.C.L. Pang and W.K. Chow

Research Centre for Fire Engineering, Area of Strength: Fire Safety Engineering
The Hong Kong Polytechnic University, Hong Kong, China

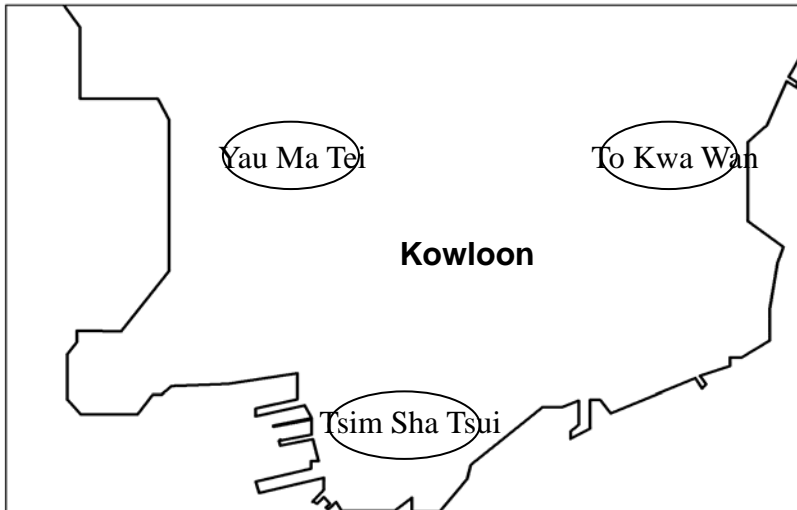
FIGURE 1. Areas surveyed

It is a multi-purpose building in To Kwa Wan (as shown in Fig. 1) constructed before the publication of the first codes of practice on FSI and there was no FSI installed. Since the owner was quite concerned about the fire safety inside, lots of renovation works were carried out in the 1990s which involved hose reel system, fire extinguishers, improvised sprinkler system, emergency lighting and manual fire system as shown in Figs. 2a to e.

It is a composite building with a restaurant in Yau Ma Tei as in Fig. 1 which has been in use since 1971 and it should have complied with the codes at that moment. Sprinkler system was added for the premise as in Fig. 3 few years ago in accordance with the legislative requirement.

It is a commercial building in Tsim Sha Tsui (as in Fig. 1) completed in 1983, and it is found to have satisfied the local codes at the time of construction. Since this building is managed by a management company with high reputation in the market, FSI installed in the building are still kept in good working conditions according to statutory requirement as shown in Figs. 4a and b. It is a good example for other building owners.
