Full-scale Fire Experiment on a Typical Passenger Train

NATHAN WHITE, VINCE DOWLING, and JONATHAN BARNETT
CSIRO Fire Science and Technology Laboratory
CSIRO Manufacturing and Infrastructure Technology
PO Box 56
Highett, Victoria 3190, Australia

A full-scale fire experiment has been conducted on a typical Australian passenger train. In this experiment a train fire was allowed to become fully developed involving all combustible materials within the train. This paper focuses on the results of the fully developed fire. The experiment was conducted outside rather than in a tunnel. Measurements included temperatures, vent flows, heat flux and gas analysis. Observations were recorded. It was found that ceiling and upper wall linings are more critical for fire spread than seats and lower wall linings. The ignition source consisted of 1 kg of crumpled newspaper, the equivalent of a Saturday Melbourne newspaper, located on the floor, beneath a seat in one corner of the carriage interior. The fully developed fire went to flashover 140 s after ignition and spread inside the vehicle very rapidly, spreading to have involved all fitted materials by 175 s. This highlighted the very short evacuat

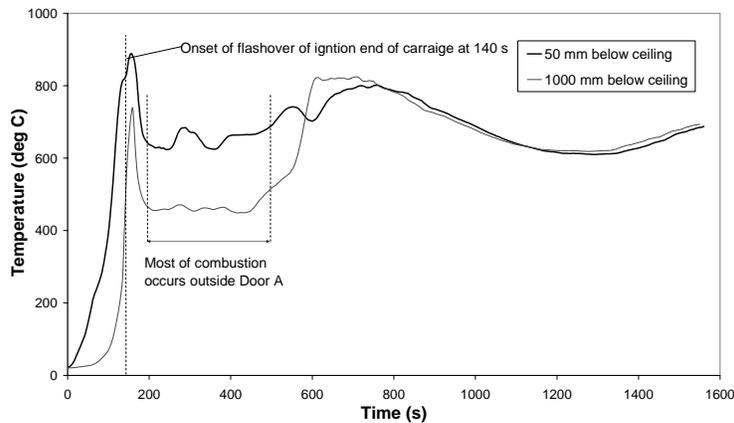
Fig. 1. Temperatures at centre of carriage 2 m from ignition point.

Beyond 600 s the temperatures in Fig. 1 converge. This is most likely due to molten material falling on the thermocouples or the thermocouple trees collapsing. Similarly located thermocouples on other trees did not converge in this manner.

Following ignition, the fire grew rapidly, with flames impinging on the ceiling at 20 s. Prior to flashover, there was only limited involvement of the seat in the area exposed to the ignition fire. The fire continued to grow on the GRP wall linings in the corner, and on the ceiling linings. Flames spread laterally along the ceiling with increased smoke production until at 140 s it was judged that flashover had occurred at the ignition end of the carriage. At this point, materials, such as carpets and seats, below the already burning ceiling at the ignition end ignited, and the fire proceeded to rapidly spread along the vehicle to involve all fitted materials. At 140 s the floor heat flux meter closest to the ignition point had reached 20 kW/m² and low height thermocouple temperatures rapidly increased. Thus the conventional criteria for flashover were met within the local ignition area. Figure 1 shows the temperatures at the centre of the carriage 2 m from the ignition location.

After the onset of flashover, during the fire peak from 150 s to 400 s, the majority of the combustion appeared to be occurring external to the vehicle in the flame plume exiting the open door closest to the ignition area. This may explain the drop in interior temperatures during this period (Fig. 1). This flame plume exhibited cyclic turbulent pulsing, and at its peak had a height of approximately 5m (extending 3 m above the roof of the vehicle), and a width of approximately 2.5 m (Fig. 6).

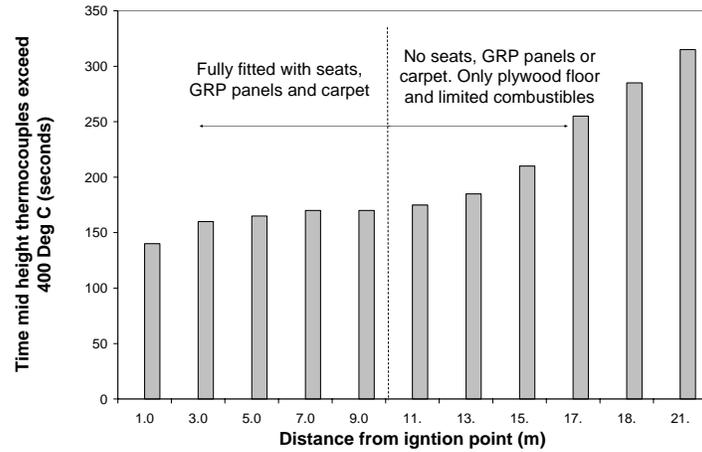
Fig. 2 shows the time to involvement of materials at thermocouple tree positions along the carriage as determined by low height temperatures exceeding 400°C.

Fig. 2. Time to involvement of materials at discrete distances along the carriage.

Following flashover at the ignition end at 140 s, the fire spread to fully involve materials at the end of the fitted area, 10m from the ignition point, at 175 s. This corresponded to a measured heat flux of 20 kW/m² at floor level in the centre of the carriage length at 175 s. Spread of fire extending more than 15 m from the ignition point was slower due to the limited combustible available to support spread. However, aluminium panels eventually melted, exposing fibreglass insulation and insulated wires, which ignited. The plywood floor ignited, extending to the furthest side door (18 m from ignition point). Beyond this, the plywood did not ignite.

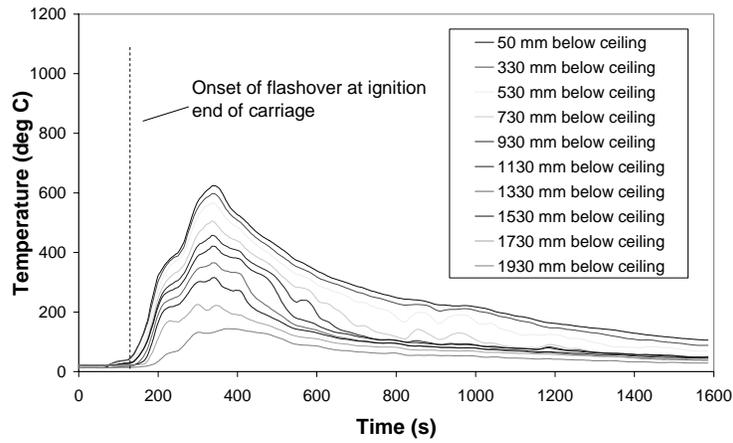
Fig. 3. All temperatures at centre of carriage at opposite end from ignition point.

Whilst there were eleven thermocouples on each thermocouple tree (see Fig. 3), for clarity only high, intermediate and low height temperatures have been presented in other figures.

Flames rolled along the ceiling and out the passenger door furthest from the ignition area, and would have ignited the GRP ceiling panels, if they had been present for the full length. Also, the temperatures at the ceiling at the opposite end of the carriage exceeded 600 °C (Fig. 3, and 4). It is evident that if the vehicle had been fitted with materials for the entire carriage length, then all materials would have become involved. At 270 s a loud crash occurred within the carriage. This is likely to have been ceiling panels falling to the floor as the supports burnt out.

Total heat flux measurements are illustrated in Fig. 11. The heat flux at floor level in the vestibule closest to the ignition point was 20 kW/m^2 at 140 s, and at the centre of the carriage it was 20 kW/m^2 at 175 s. This compares well with the observed times to full involvement at different locations in the vehicle shown in Fig 3.

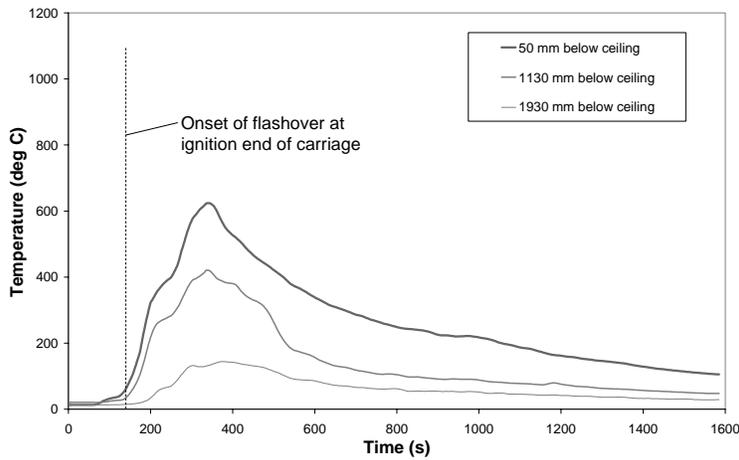
Fig. 4. Some temperatures on centreline at end away from ignition point.

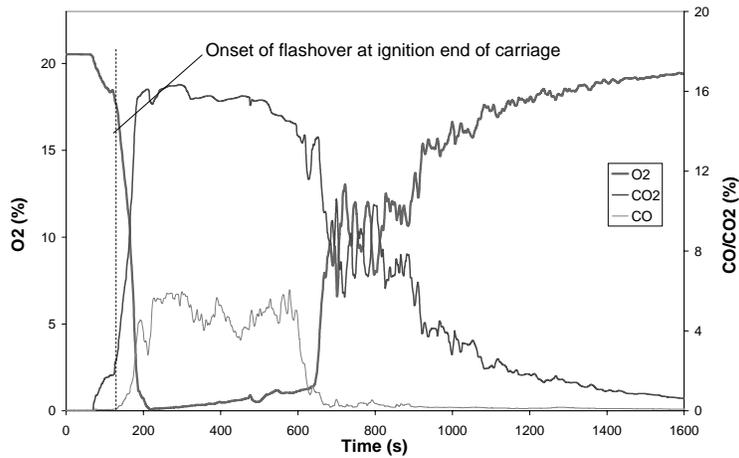
At the onset of flashover at 140 s, the smoke layer dropped, providing no visibility within the carriage and untenable conditions rapidly developed, as shown in Fig. 5.

Fig. 5. Gas concentrations at head height within carriage.

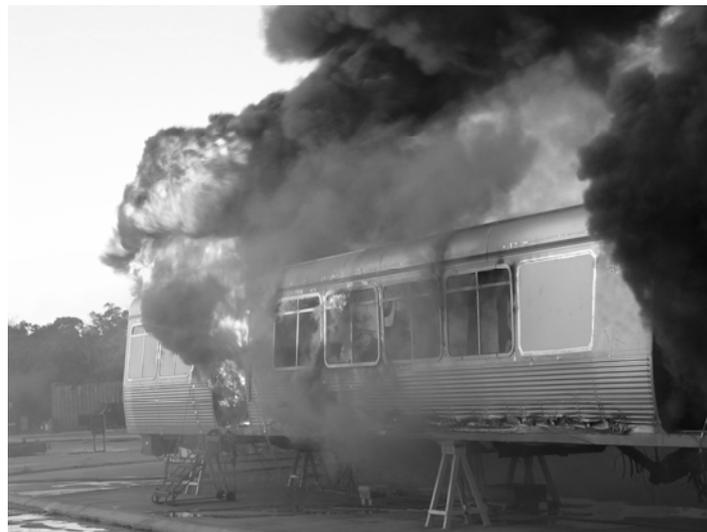
Fig. 6. Fire plume out door closes to ignition point at 3 minutes.

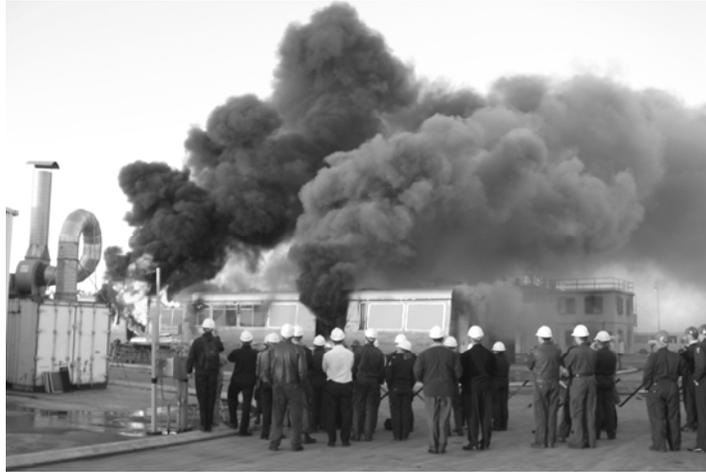
Flames also travelled along inside the carriage, and flowed out the passenger door at the opposite end of the vehicle from 270 s to 370 s. A high rate of smoke production was observed during the fire peak, as shown in Fig. 7.

Fig. 7. Smoke production at 3 minutes.

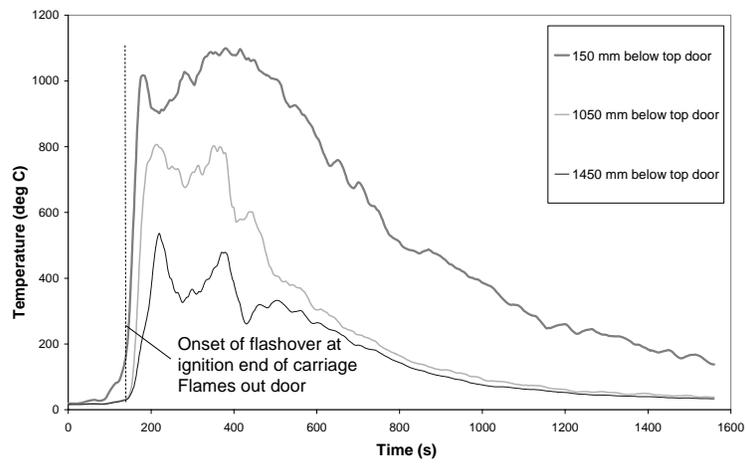
The temperatures at various heights for both passenger doors are shown in Fig. 8 and Fig. 9.

Fig. 8. Some gas temperatures at the open passenger door closest to ignition point.

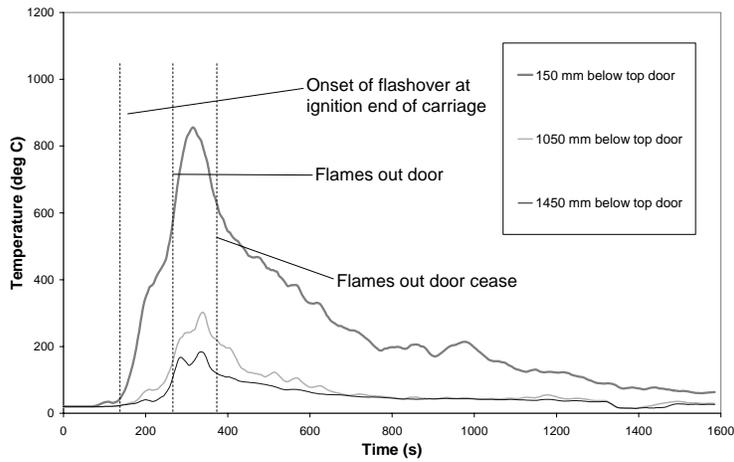
Fig. 9. Gas temperatures at open passenger door furthest from ignition point.

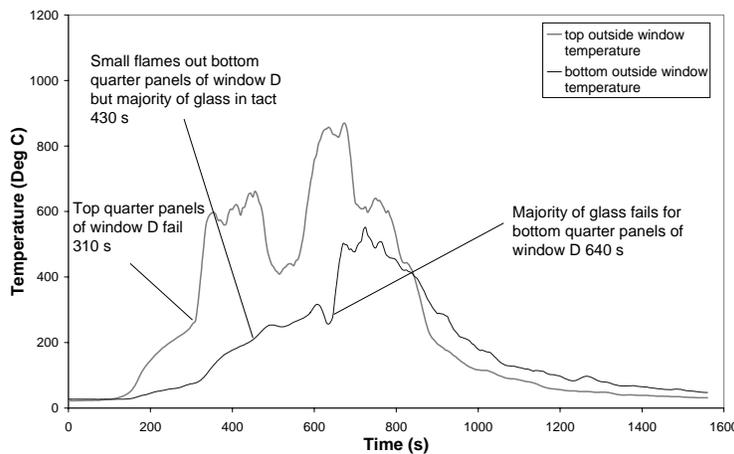
Window glazing maintained integrity, preventing significant increases in fire ventilation throughout the peak of the fire. The upper openable panels, which were single layers of toughened glass, began to fail at approximately 280 s. However, these represent a much smaller vent area than the lower fixed panels. The lower panels, which were double glazed with laminated and toughened glass, began to fail at 380 s. By the time a significant area of windows had broken, the fire had begun to decay. If windows had broken during the fire peak, this would have resulted in increased HRR. Typical temperature data for a window located next to the side passenger door closest the ignition point is given in Fig. 10.

Fig. 10. Some temperatures outside the second window from the ignition point.

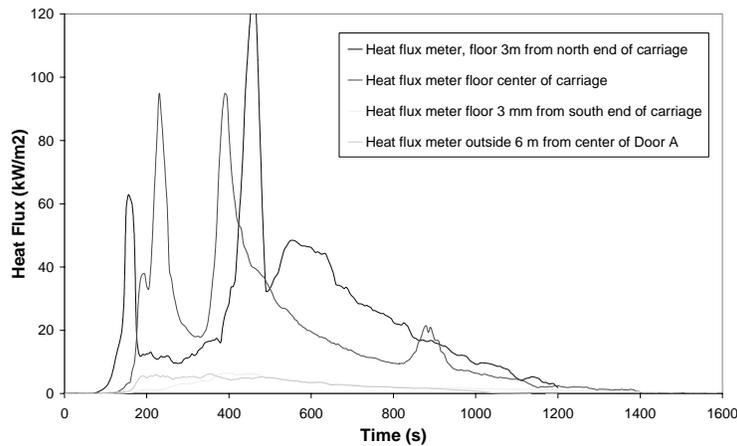
Fig. 11. Total heat flux.

The heat flux at floor level in the centre of the vestibule furthest from the ignition point does not exceed 6.5 kW/m^2 . This is mainly radiation from the hot layer, as there was limited combustion at this end of the vehicle (the plywood floor past the door did not ignite). The heat flux external to the vehicle measured at a point 6 m from the side passenger door closest the ignition location maintained a steady $5\text{-}6 \text{ kW/m}^2$ from 190 s to 350 s and then steadily decayed. A heat flux of 2.5 kW/m^2 is commonly used as the tenability limit for evacuation in a fire [9]. Exposure to a heat flux of 6 kW/m^2 causes pain in 8 s and blistering of the skin in 20 s.
